Example of report showing details and comments

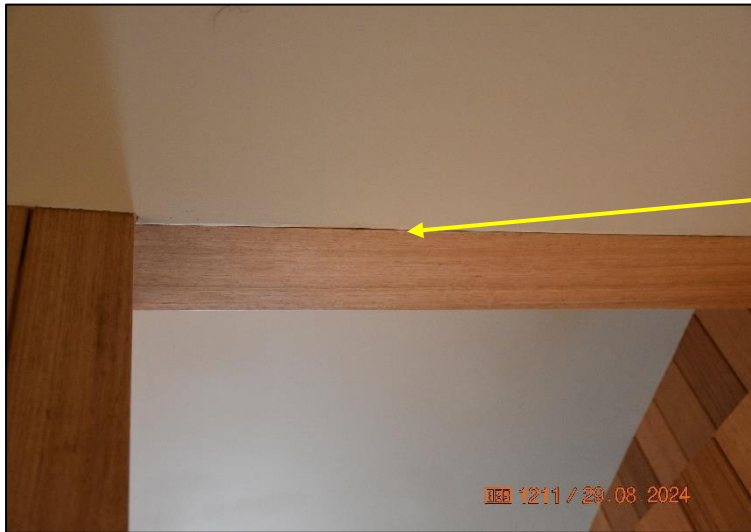
Selected Photograph N 19

Photo No 19 shows a timber infill between two sections of ceiling in the hall.

Like some areas of plaster and timber interface there is a slight gapping that needs to be filled to provide a smooth even appearance and not what appears to be small gaps.

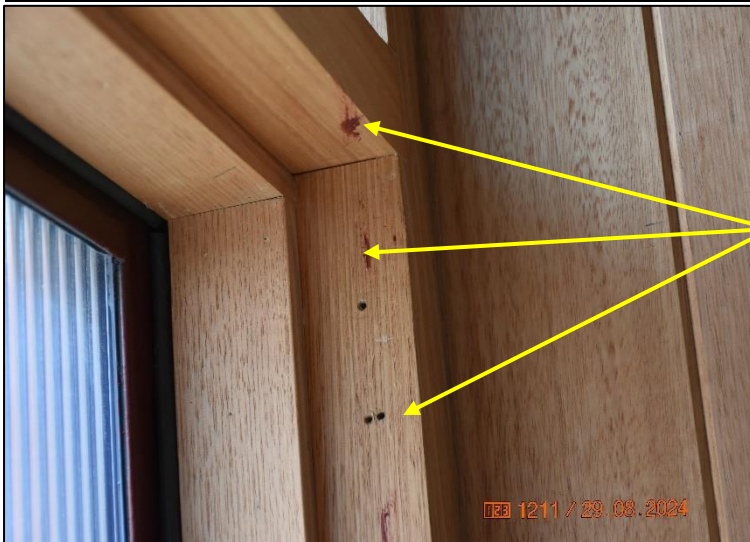
Selected Photograph No 20

Photo No 20 shows a section of window frame in the bathroom.

The holes in the timber need to be filled and what appears to be red paint needs to be removed, and the windows re-oiled to provide an even blemish free finish.

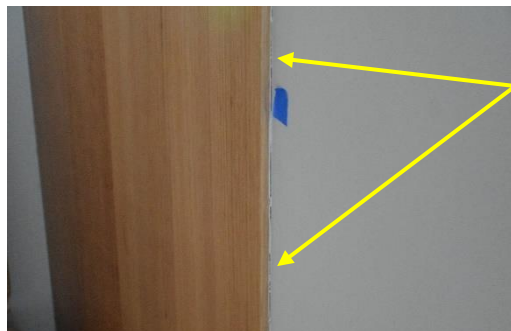
Selected Photograph number 21

Photos No 21 and 22 show sections of wall interface between the timber panelling and the plaster.

Areas such as these need to be filled and the wall area recoated, not just touched up but the entire wall recoated to ensure a smooth even finish.

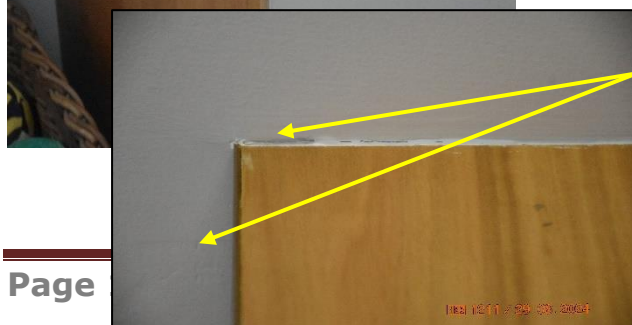
Selected Photograph No 22

It's also noted that around this area there is evidence of picture framing, that is brushstrokes not properly over coated with the roller.
